2020 Operations, Maintenance, and Monitoring Report

Sabine Structure Replacement

State Project Number CS-23
Priority Project List 3

December 2020
Cameron Parish

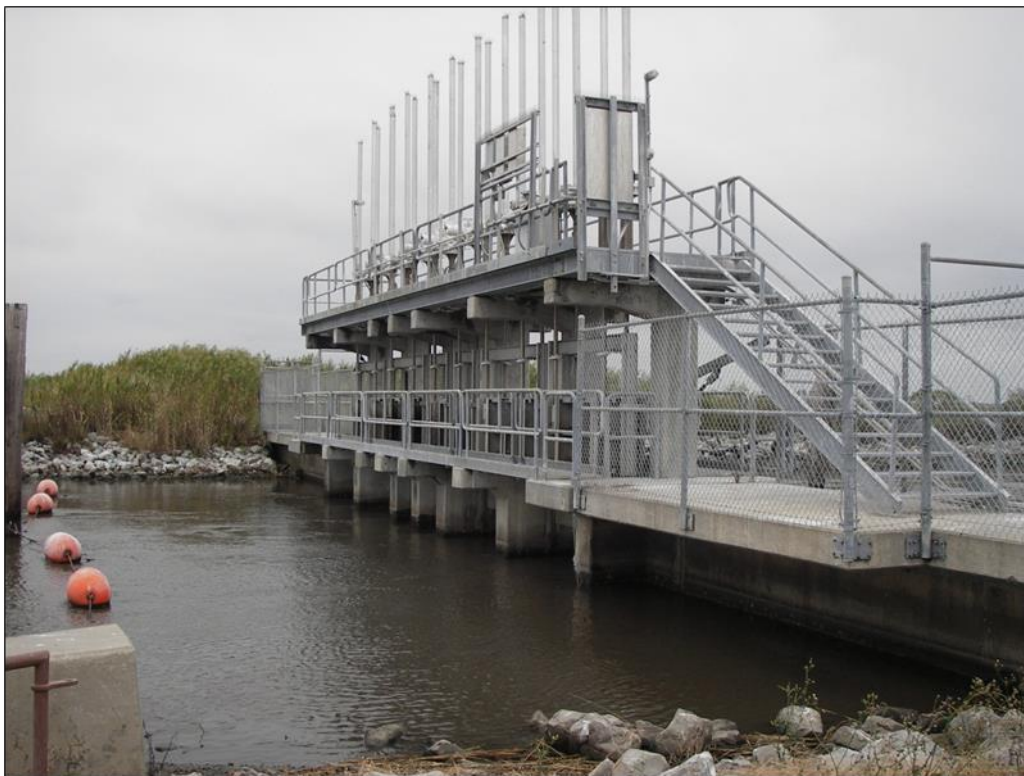
Storm surge from Hurricane Laura scoured around the ends of the structure. Damage can be repaired with placement of soil and rip rap. A boat barrier cable and buoy have detached from the timber pole danger sign. (Photos: Appendix A, Photos 1 - 2)

Photo No.1, Hog Island Gully Structure looking from the Hwy 27 side.

A maintenance event to perform targeted canal cleanout in the project area was proposed and approved in the Fall of 2020. The storm related damage can be folded into this larger maintenance event. This work should be completed by the end of 2021 or early 2022.

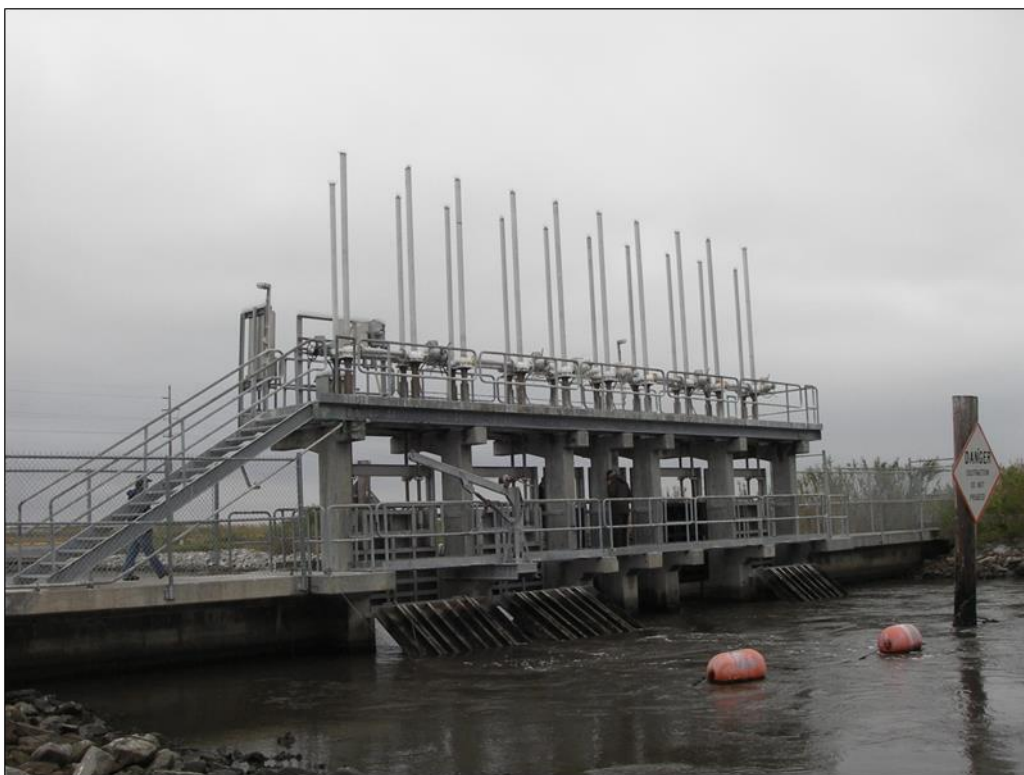
Photo No. 2, Hog Island Gully Structure from the Calcasieu Lake side– gates being exercised and in open position

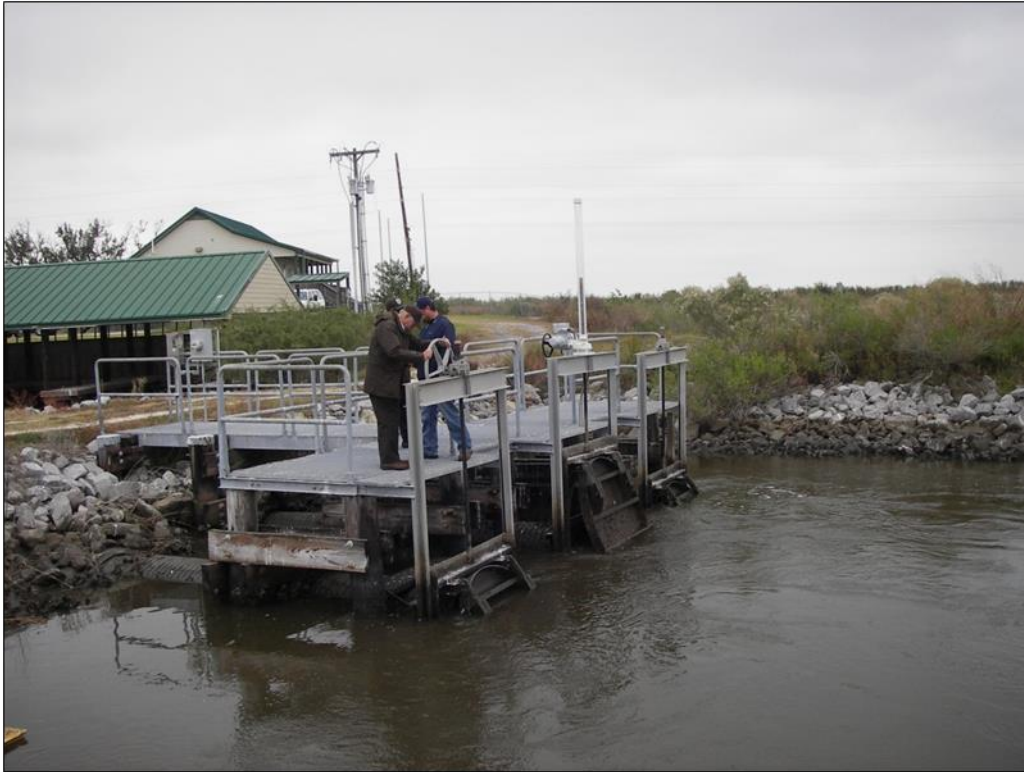
The refuge headquarters facility is closed and the gates were locked. Therefore, close assessment was not able to be made. Observing the structure from across the canal, it appeared that the structure did not receive any damage. (Photos: Appendix A, Photos 3).

Photo No. 3, Headquarters Structure with outside flapgates flapping

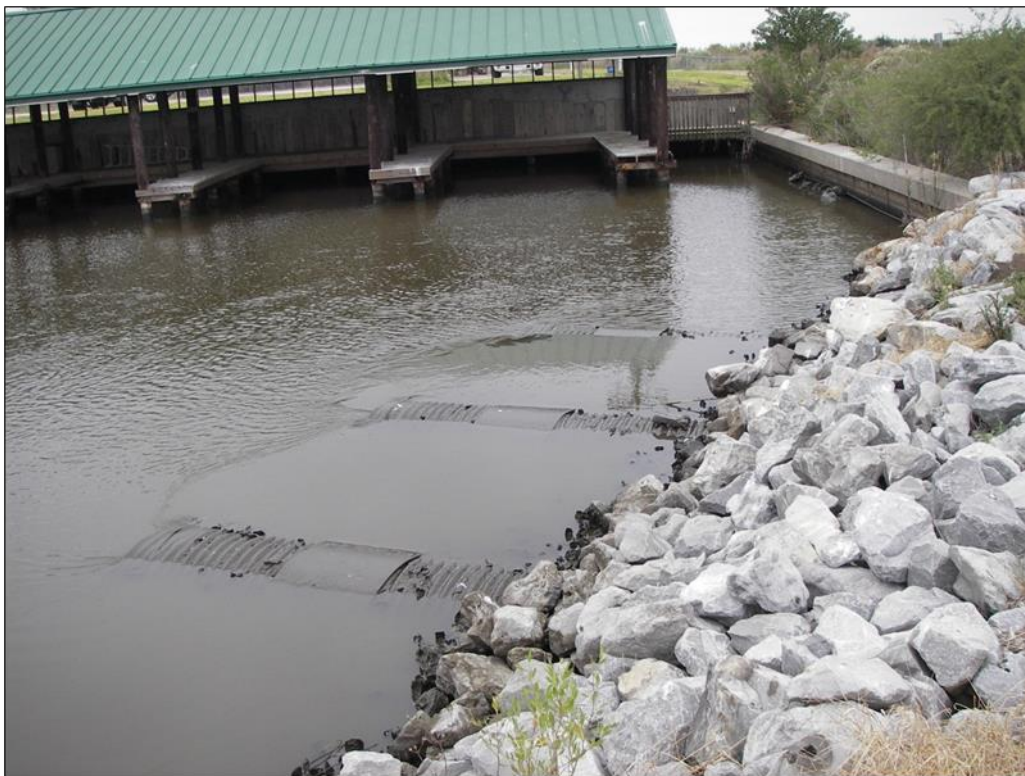
Storm surge from Hurricane Laura scoured around the ends of the structure. Damage can be repaired with placement of soil and rip rap. There was also damage to the various fishing piers (not maintained by CWPPRA). (Photos: Appendix A, Photos 4 - 5).

Photo No. 4, Headquarters Structure marsh side culverts with riprap

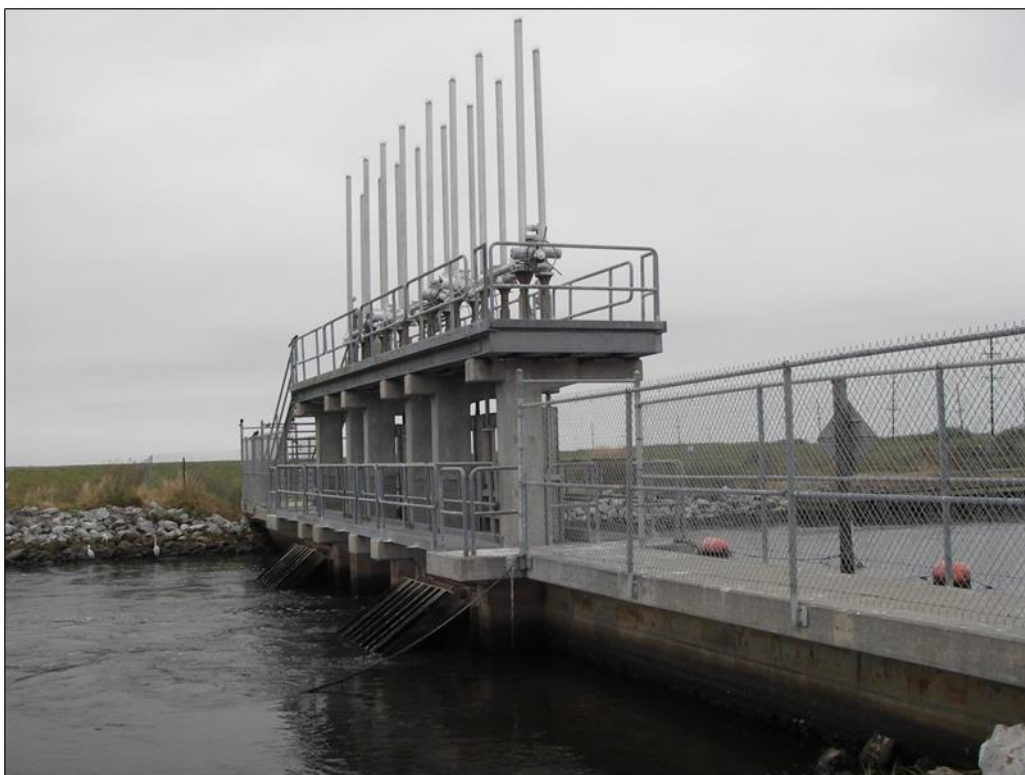
Photo No. 5, West Cove Canal Calcasieu Lake side of structure with flapgate flapping

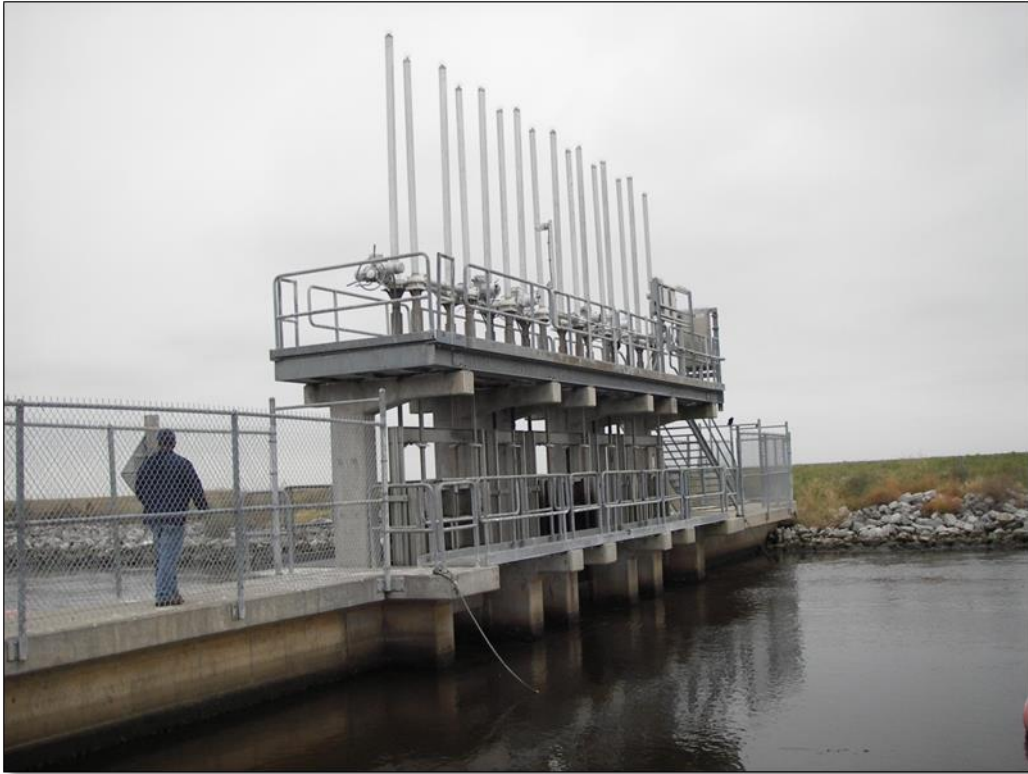
Photo No. 6, West Cove Canal from Hwy 27 side – gates being exercised and in open position
